August 7, 1969  
M & R No. 39675

EVALUATION TESTS OF  
"DEFIANT SELF RECTIFYING SAFETY STEEL POST"  
MANUFACTURED BY DEFIANT INTERNATIONAL, INC.

69-11

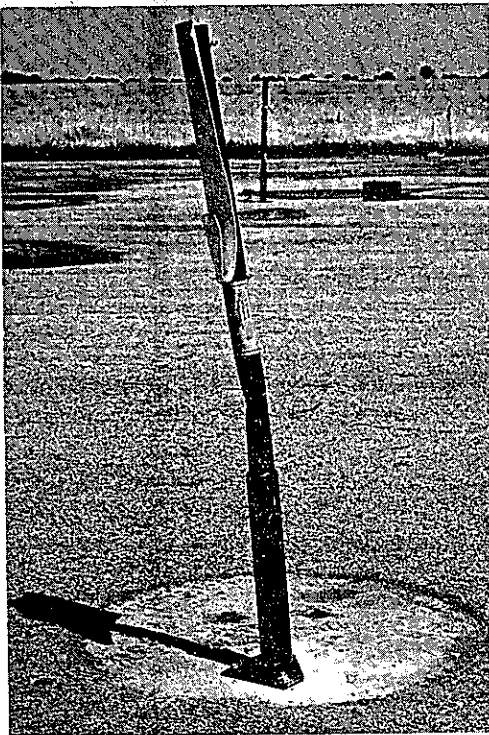
FIGURE 7

Test No. 1 was a 60 mph head-on impact into the 48-in. high unit. The test driver reported no significant physical and only a slight audible indication of impact. The device deflected down on impact and rebounded immediately to the upright position after passage of the vehicle over it. Although permanent damage to the post appeared to consist only of a slight final bend (approximately 6°) at the point of impact with the bumper (Figure 7), high speed film analysis showed the unit initially bent approximately 20° upon impact. The slapping of the post against the ground took much of the initial bend out. The guide plate was deformed with all three center-mount reflectors stripped off. There was no damage to the base, but the return spring did appear to lose some of its tension. Operation of the device was unaffected although a noticeable "wobble" was evident. Damage to the vehicle was very minor and consisted only of a ½" deep concave dent in the leading edge of the bumper and hood (Figure 8).

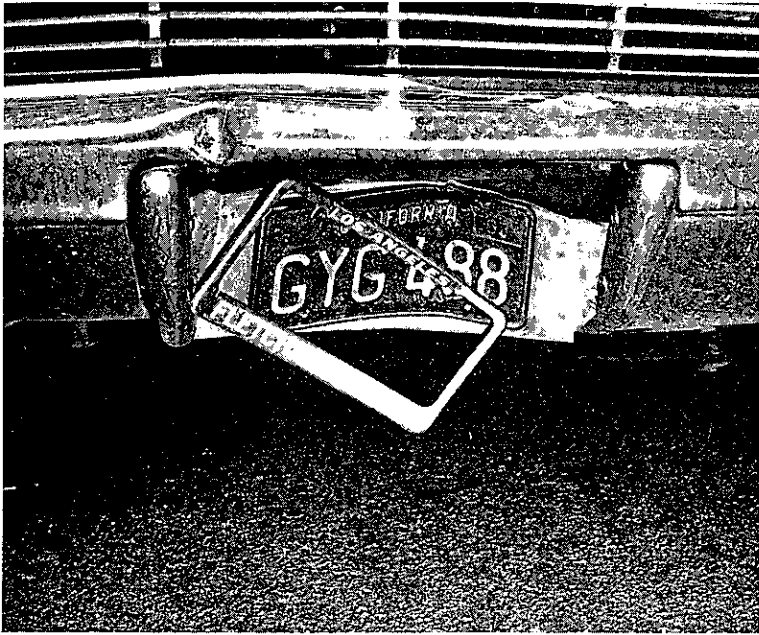
FIGURE 9

Test No. 3 was a 60 mph head-on impact into the 18-in. horizontal unit. Collision into this shorter unit produced a slightly more physical and audible indication of impact. This was primarily attributed to the fact that the point of impact on the vehicle was at a less rigid point on the front bumper, deforming it approximately 4-in. (Figure 9). There was no damage to the post which rebounded immediately to the upright position. There did not appear to be any loss of spring tension as observed on the 48-in. unit. The guide plate was deformed beyond repair with all three reflectors either stripped off or badly damaged (Figure 10).

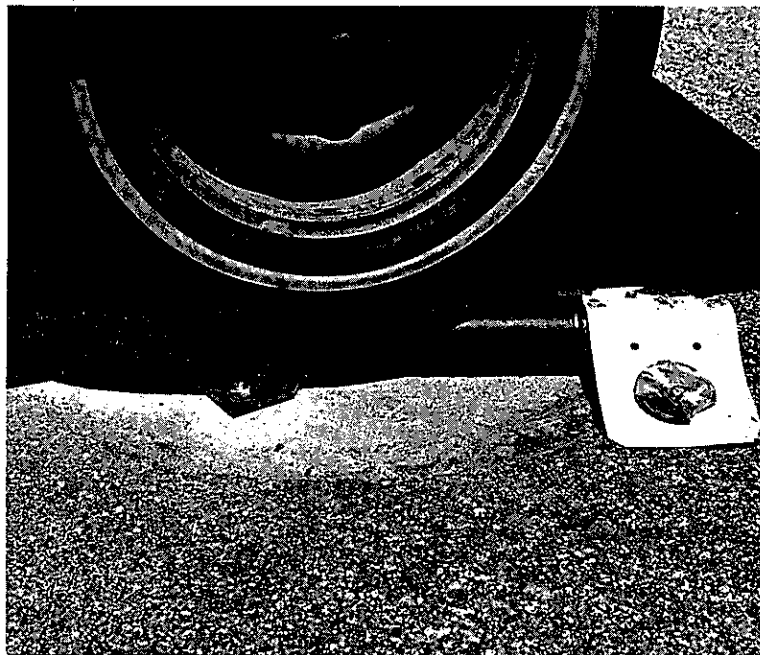
FIGURE 11

Test No. 4 was a non-impact test where the vehicle wheel was driven directly onto post of the 18-in. unit, deflecting it flat against the pavement. As the wheel was driven off, the post snapped back to the upright with no apparent damage (Figure 11).
